Gladstone Park

Fred Kormis Memorial

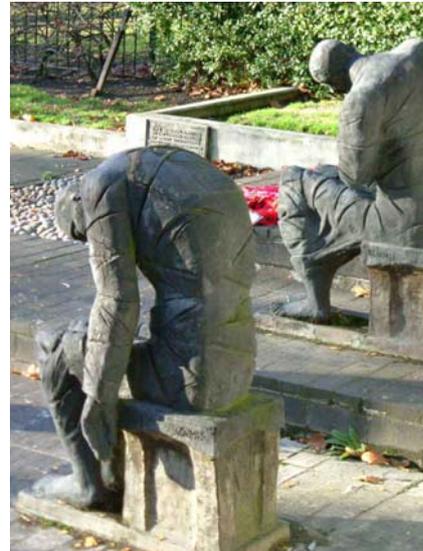
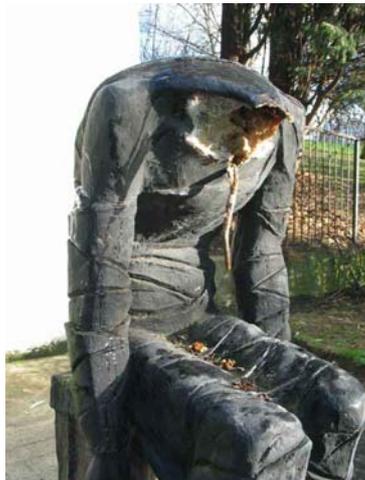
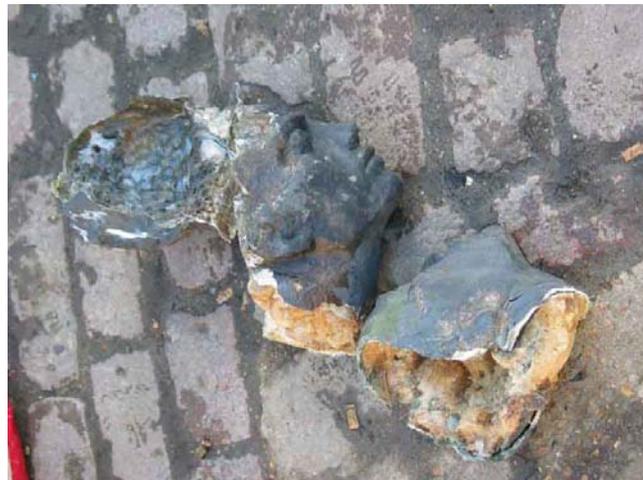
The fibre glass figures were in urgent need of attention when the project began on site in October 2003 as they had been neglected, allowing their steel armatures to corrode severely. The surfaces of the figures required extensive cleaning as they had been painted matt black following an incident when they were sprayed with bright yellow graffiti. This resulted in a very somber appearance and also meant that much of the definition of the figures was lost greatly reducing their impact.

The sculptures were further vandalised on Christmas day 2003 when their heads were smashed by a person or group using a wooden paving mallet, badly damaging one of the figures and decapitating all of the others. We searched the surrounding undergrowth and managed to find the faces of all but one of the heads and other bits and pieces which could be painstakingly pieced back together by our conservators, unfortunately one head could not be found.

Specialist conservators Holden Conservation, based in west London have been working for the past few months to rebuild the figures which were taken off site earlier in the year. The figures were initially split open so that the internal armatures could be removed and replaced in stainless steel and the foam filler which was accelerating their deterioration has been replaced.

Chemical analysis was carried out on the surface of the sculptures and the composition of the original 'gel coat' surface finish was ascertained allowing the conservators to accurately replicate the original bronze finish. To reconstruct the missing head, the conservators used archives at the Imperial War Museum which included an original maquette of the sculptures.

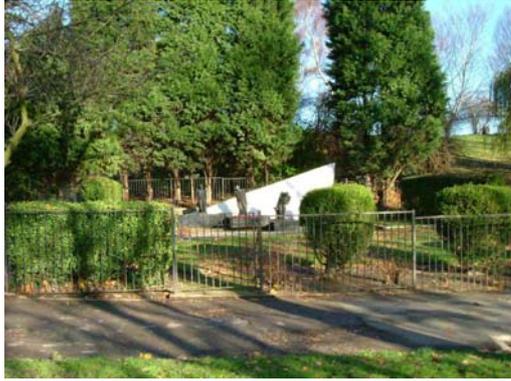
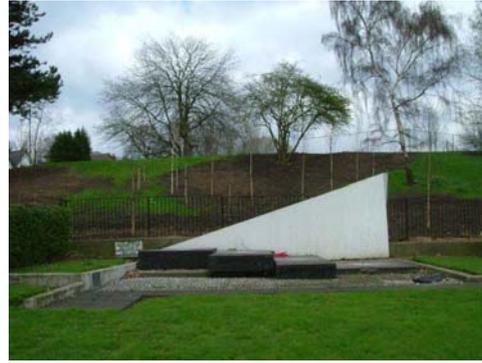
Fred Kormis had wanted the figures to have a architectural setting within a building that had been bombed during WWII, this was never achieved however and they were sited in Gladstone Park. The staging and concrete wall are typical of the time and have been repaired, cleaned and repainted and the perimeter railings have been removed and replaced. The planting scheme had been allowed to over mature over the years with a coniferous hedge at the rear which had turned into an impenetrable wall of vegetation. This has been removed and a new mixed hedge has been planted as a backdrop with a birch grove set further back on the existing bank. All of the planting in the foreground has been renewed with the conifers being removed and replaced with low level planting and more visually penetrable magnolias. New sightlines have been opened up to the memorial from a nearby residential road, which will hopefully make it less susceptible to future attacks.

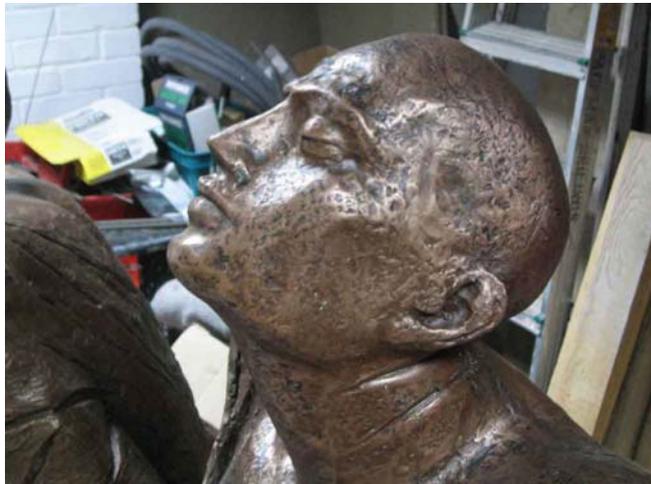
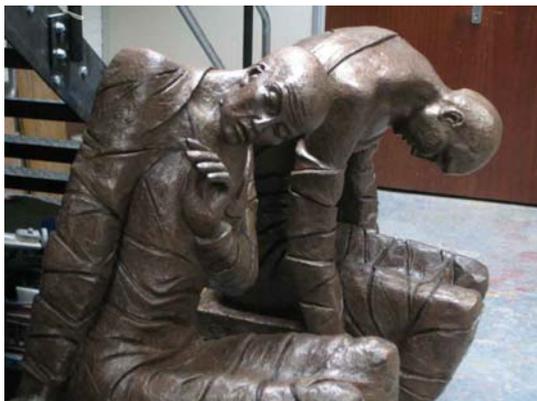
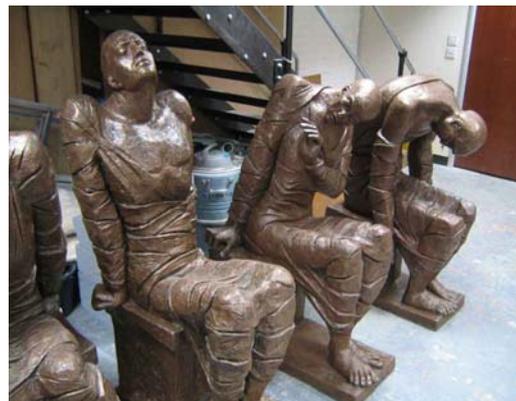
The transformation of the figures has been incredible and the increase in definition of details means that the forms of the figures and the expressions in their gaunt faces can once again be experienced, evoking some quite harrowing feelings as no doubt the sculptor intended.
